Phase One Environmental Site Assessment
King Street West, Gananoque, ON
PT LT 11, CON 1 LEEDS PT 1-5 28R5002; GANANAQUE

Prepared for:
9695443 Canada Inc.

Prepared by:
ASC Environmental
1305 Princess Street
Kingston, ON K7M 3E3

Phase Two Environmental Site Assessment

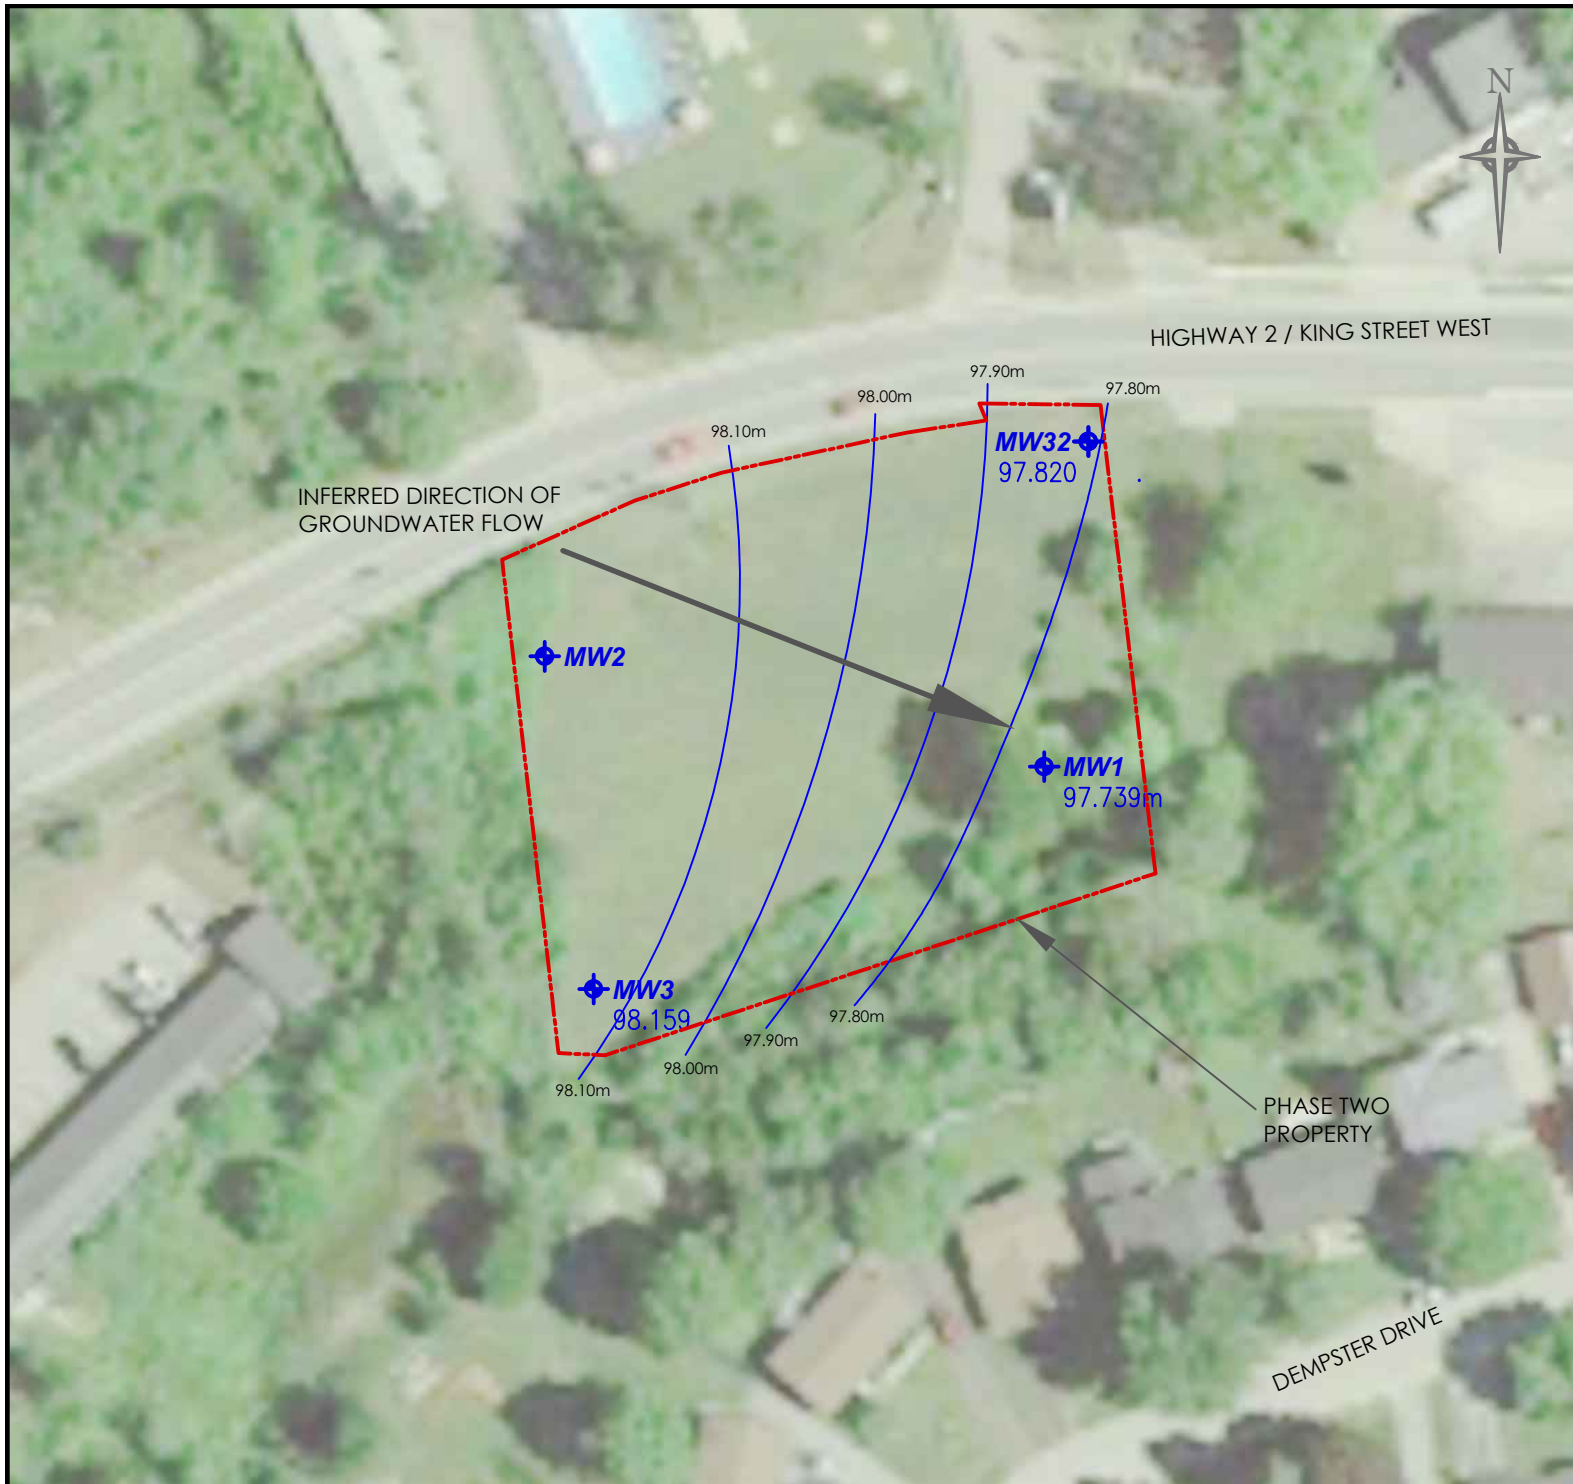
LEGEND	
	SUBJECT PROPERTY
	MONITORING WELL
97.870	GROUNDWATER ELEVATION (JULY 14, 2020)
	POTENTIOMETRIC LINE
	INFERRED DIRECTION OF GROUNDWATER FLOW
